# Suomi-NPP Mission On-orbit Experience with Toroid Ball Bearing Retainers under Unidirectional and Reversing Motion

Otto Bruegman\*, Kamal Thakore\*\*, Stu Loewenthal+ and John Cymerman\*\*

## Abstract

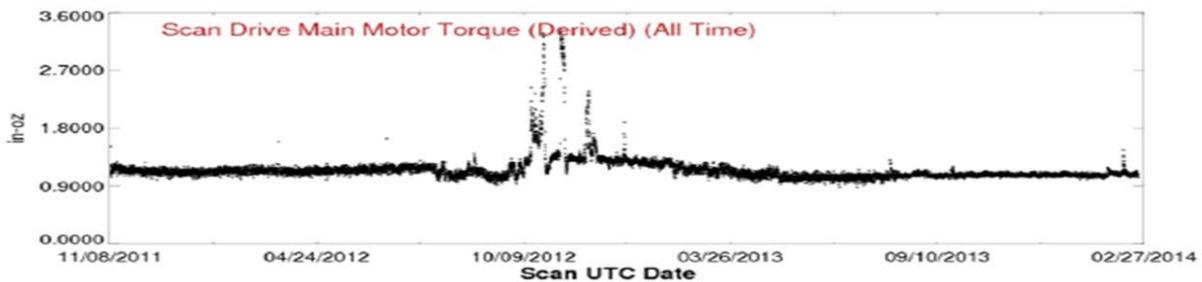
Figure 3 provides some information on the initial on-orbit observation. This shows the main torque trend from the beginning of mission to end of February, 2014. The transient in late 2012 returns to the previous nominal condition on its own with no intervention from the ground or otherwise.

**Figure 3. On-Orbit Main Motor Current – showing the torque spike in late 2012**

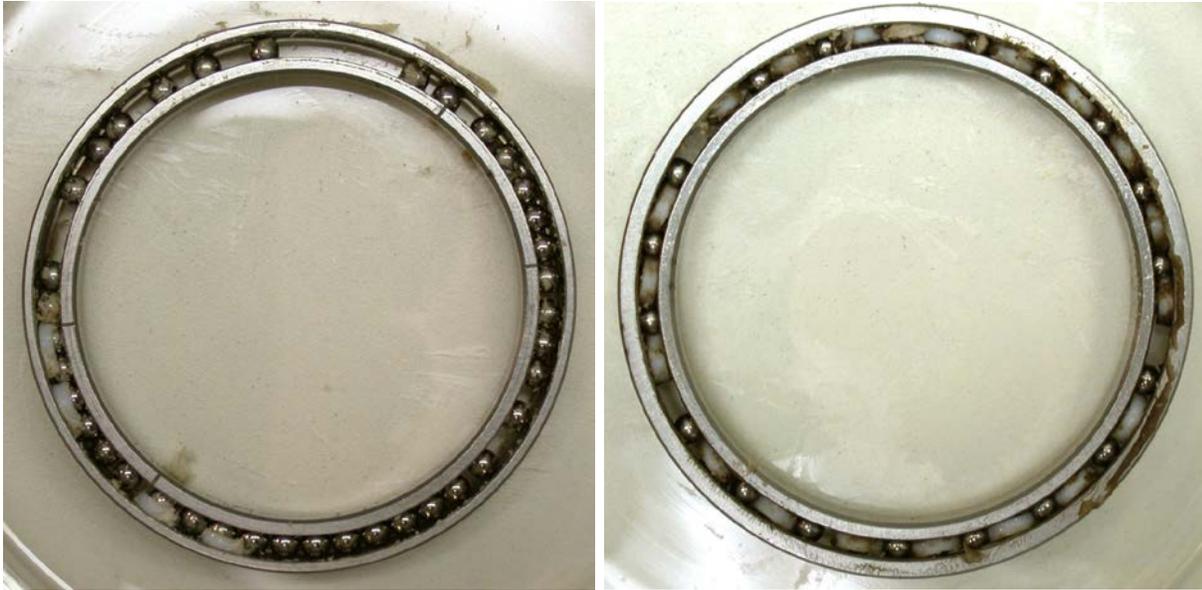
Test unit 2 started experiencing higher torque spikes at about the 5 year mark of its 'operational' life. The torque generated by the unit exceeded limits at the 5.3 year mark of its life (2/20/2009). At this point, the unit was disassembled to inspect the bearings. It was found that the bearing toroids had experienced severe wear. The toroids of one end of the bearing pair were almost totally destroyed and the other bearing showed severe wear of the toroids. The temperature of the test units was initially set at 41 °C as a predicted worst case temperature. In the September 2012 timeframe the temperature was changed to more closely match that of the measured on-orbit values. The test unit temperature was changed from 41 °C to 18 °C. At the time, it was thought that the accelerated wear of the test unit #2 bearings was the result of an overly conservative temperature prediction leading to a premature loss of lubrication.

Figure 4 shows the wear of the bearing toroids for test unit 2. The left picture shows the 'heater' end bearing and the left shows the 'encoder' end bearing. The 'heater' end bearing was thought to run at a slightly higher temperature than the other, leading to more severe wear.

**Figure 4. Test Unit #2 bearing condition from 2009 disassembly**

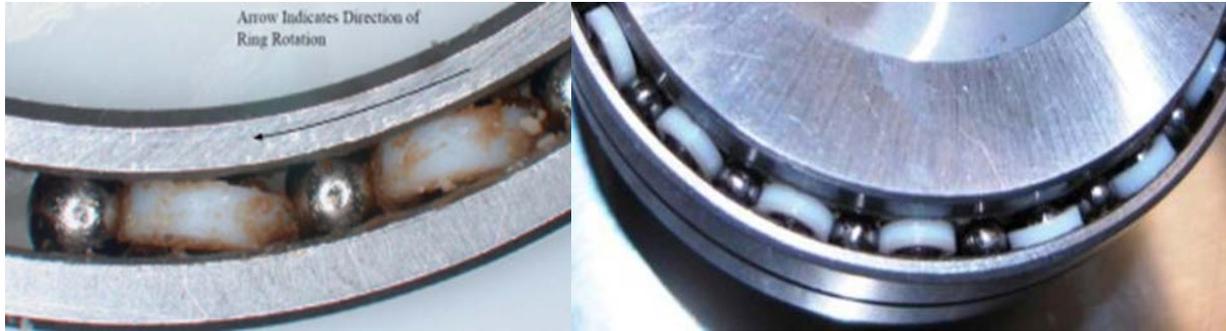
A comparison of the Test Station #2 life test bearing with rotation in one direction and a similar life test bearing that rotated equally in both directions is shown in Figure 5. The bi-directional bearing is clearly in much better condition than the ATMS bearing despite achieving six times the number of revolutions.

**Figure 5. Comparison of Test Station#2 bearing with a similar bearing in relatively good condition with equal direction reversals after 6X times the number of revolutions.**

**Left Figure:** ATMS uni-directional test bearing at 63 Mrevs

**Right Figure:** Similar bi-directional bearing at 362 Mrevs

Reversing bearing rotational direction minimizes toroid wear because it reduces the chance for the toroids to get stuck/pinned in one orientation. The toroid that is pinned by the driving ball will tend to rub in one spot causing the lubricant to dry out and also inhibits the supply of fresh lubricant. The photos of the worn toroids from post-test inspection (see the next section) clearly show that the toroids were locked in one orientation forming ball pocket wear divots. From the steel ring-on-block tests reported in Reference 3, the wear rate of unlubricated (dry), PTFE test samples was >1000 times the wear rate of those lubricated. This obviously has a major effect on toroid wear life.

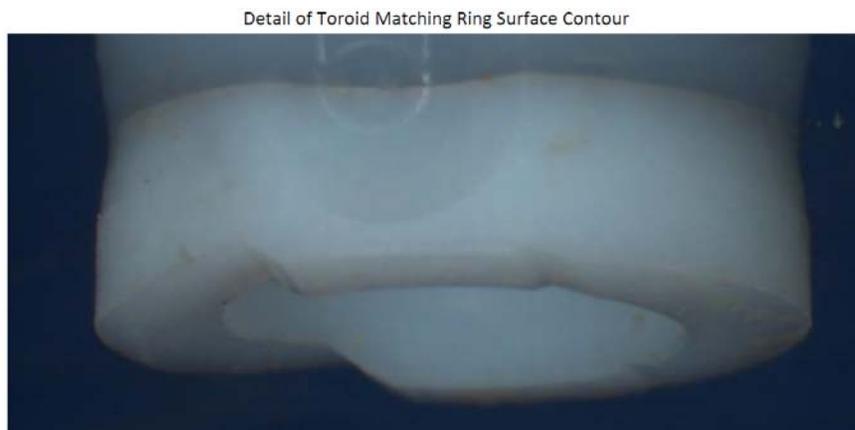
**Figure 7. Sample Bearing Toroid – Test Station #2**

The wear patterns noticeable in the test station #2 toroids had a variety of configurations, but the one shown above is most telling. It shows that the bearing races had a significant contribution to the wearing of the toroids. However, the major mode of wear that led to the destruction of the toroids was the one where the balls wore an ever deepening 'dimple' into the toroid that led to the disintegration of the circular geometry. In other words, the 'dimple' went so deep that the toroid split in two. Subsequently, the toroid halves were ground up by the continuously rotating bearing elements – thereby causing the current spikes that were observed in telemetry. The grinding up of the toroid material led to the creation of a slurry of Teflon particles and lubricant outside of the bearings. There were no intact toroids in either of the two bearings from test station #1 indicating the test station bearings were run well beyond their useful lives.

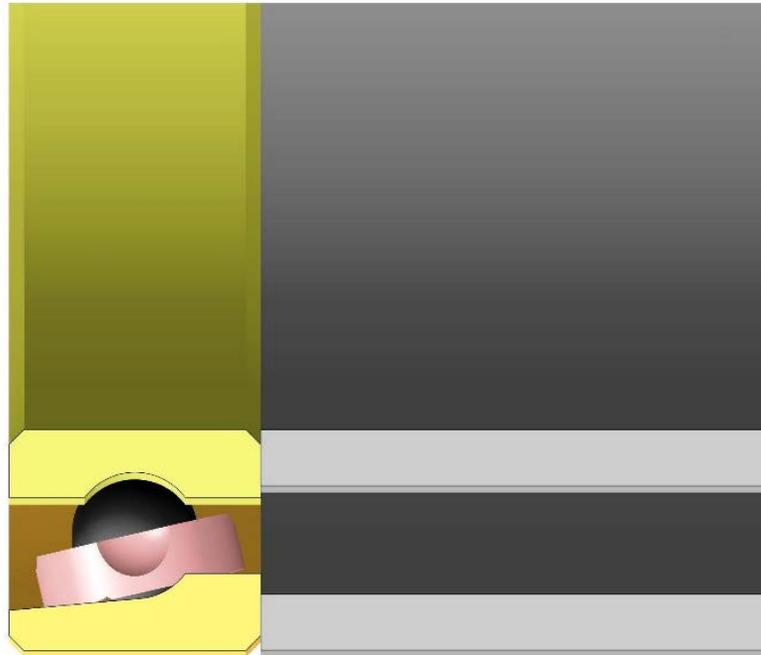
**Figure 8. Modeling of Toroid Wear of Sample Pictured in Figure 7 – Test Station #2**

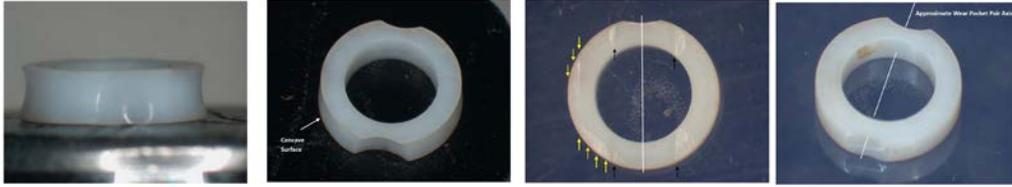
For the purposes of showing the variety of the wear patterns of the toroids from test station #2, Figure 9 is offered. The first picture shows a concave toroid wear pattern suggesting that this toroid was rotating and distributing wear around the toroid circumference. The remaining pictures show ball wear pockets indicative of toroids that got stuck in one position accelerating wear

**Figure 9. Toroid Wear Patterns (test station #2)**

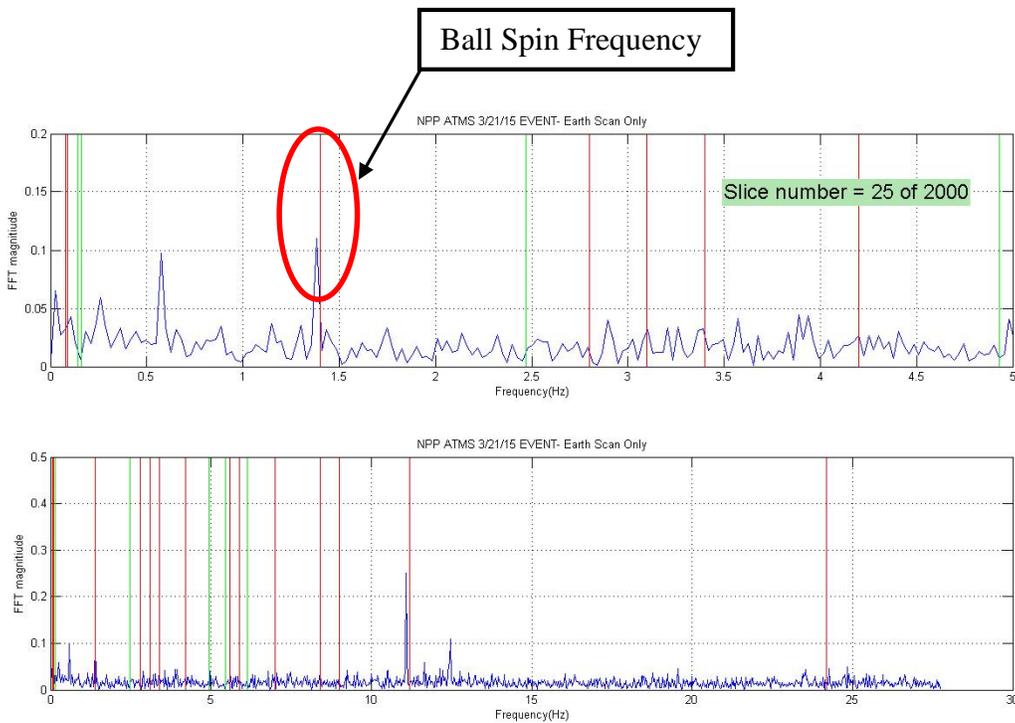
**Figure 10. FFT Results showing Ball Spin Frequency response**

The end result of all the investigation and analysis lead to the conclusion that the ball toroid interface was running dry. The operation of the mechanism in one direction was not allowing for the re-orientation and hence re-lubrication of those surfaces of the toroids. Thus began a rapidly advancing wear of the softer material (Teflon toroids). As the 'pockets' in the toroids got deeper, the harder it was for any re-orientation of the toroids to occur.

Once the wear mechanism was understood, the effort was turned into one of developing a mitigation that could be implemented on-orbit with minimal impact to the science provided by the instrument. With the experience in hand of another program that used the Teflon toroids successfully, it was suggested that a modified scan pattern be implemented to allow for the re-orientation of the toroids. We looked long and hard at new permutations of the instrument scan profile. Eventually, this led to the suggestion of doing some limited number of reversals at a point in the spacecraft orbit that would have negligible impact to science. The SNPP science team came to rescue by suggesting that the instrument science would not be significantly impacted if a limited number of reversals were implemented at a high latitude point in the orbit. Eventually, we settled on doing the reversals above 74 degrees North latitude.

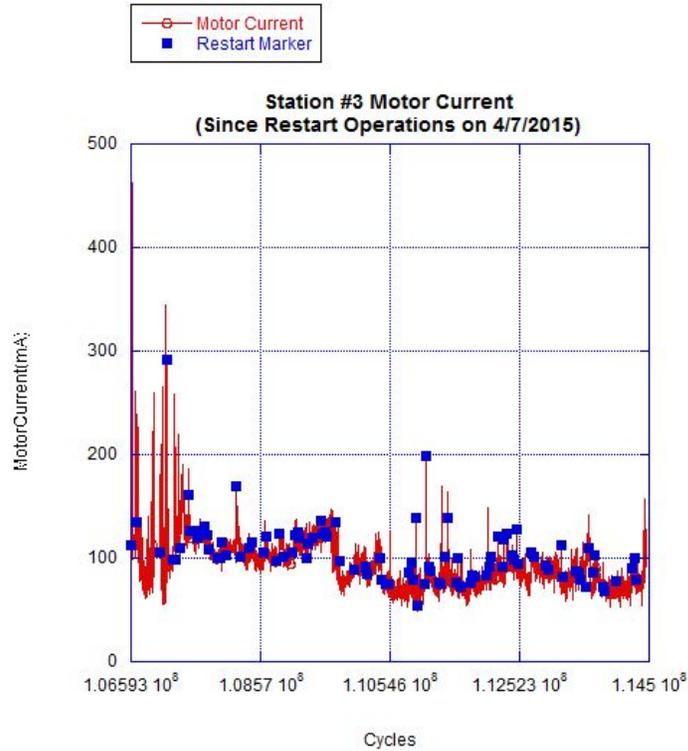
It is anticipated that the toroids in the test station #3 bearings are compromised to some extent, but no definitive statement can be made as to their actual state. It would be logical to expect that the station 3 toroid condition is somewhere between the states of the disassembled test stations 1 and 2.

The reversals on test stations 1 and 3 were successful in giving these bearings new life. However due to the debris generated by the failure of the toroids, some torque spikes are expected to occur. The toroid debris is being ground up by the action of the balls against the races. It is thought that the reversals arrest the further degradation of intact toroids as contact surfaces are being re-wetted with remaining lubricant.

Figure 11. Motor Current of Test Station #3 (12/08/2015) – blue squares indicate reversals

The six reversals per day were tested on two running bearing test stations at different times. At this period of time, both stations were down because both stalled in late 2014 due to high torque and were shut down pending new engineering direction. The reversal testing was started on test station 3 in April 2015 while test station 1 was restarted in March of 2015 running the normal scan profile without reversals. While test station 3 was being used for reversal testing, test station 1 stalled in early August of 2015. At this point in time we needed to develop more experience with reversals, so we decided to restart station 1 doing daily reversals. At first, test station #1 was reluctant to re-start, but eventually did in mid-August 2015. Test station #1 was run with the daily reversals for about a month before its disassembly. At the time of its test termination, test station #1 was past its 2X mission life. Test station #3 continues to run with good results and is almost at its 2X life point as this is being written. Figure 11 shows the motor current data for test station #3 as of December 8, 2015 and Figure 12 shows the motor current for test station #1.

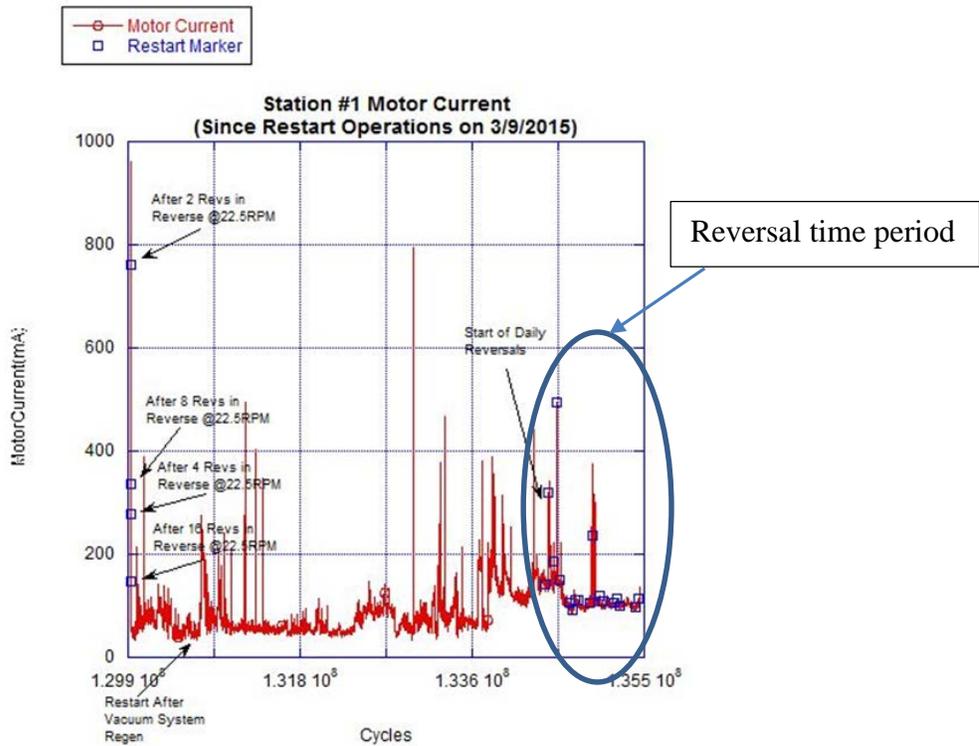
Figure 12. Motor Current of Test Station #1 (9/16/2015) after 11.5 years of equivalent operation prior to disassembly. Note the more stable level of motor current after reversals.

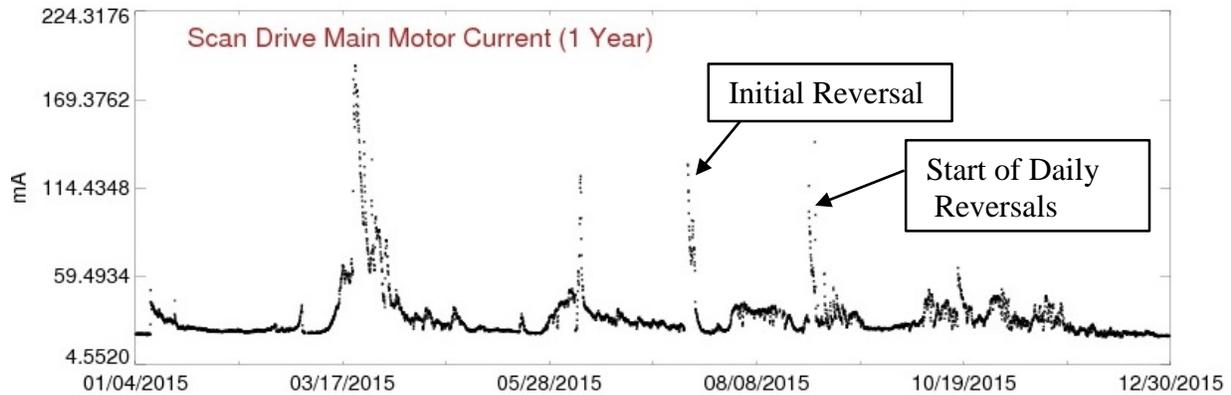
Figure 14 is provided to capture the scanner main motor current for the past year. It should be noted that the motor current level is now at start of mission values. This would indicate that the reversals are effective in re-lubricating the bearing/toroid surfaces. Also, the reversals may allow the toroids to re-orient themselves exposing freshly lubricated Teflon surfaces to contact the adjacent balls.

**Figure 14. Scan Drive Motor Current 1 Year History**

The on-orbit reversal process was initiated on July 14, 2015. It consisted of a table load and its verification and then followed by the first reversal sequence. The first reversals were done by ground command, which put restrictions on how fast people and command systems can operate. This resulted in approximately 26 reverse direction rotations of the scanner before the return of normal forward scan operation. This reversal resulted in a motor current spike that died away after about 3 days, which is faster than previous ‘naturally occurring’ current spikes. A result like that was anticipated based on bearing test set reversals. The reversal command process was implemented via the spacecraft Daily Activity Schedule command load on August 24, 2015. This simplified the command implementation and had the effect of implementing the reversals as part of normal spacecraft operation – basically making it seamless. It also had the result of fixing the number of reversals at the desired number of six contiguous reversals per day.

The daily reversals have been performed without interruption since August 24, 2015. Only one noticeable motor current ‘event’ has occurred since then and that happened early in the process on August 26, 2015. Since then the motor current has been rather stable with only small perturbations.
