LESSONS LEARNT FROM THE ROOT CAUSE INVESTIGATION ON THE SAD-LP SOLAR ARRAY DRIVE MECHANISM

Brian Wood, Paul Joachim Schüngel, Guido Sutter & Andrew Skulicz

*Oerlikon Space AG, Schaffhauserstr. 580, 8052, Zürich, Switzerland
brian.wood@oerlikon.com*

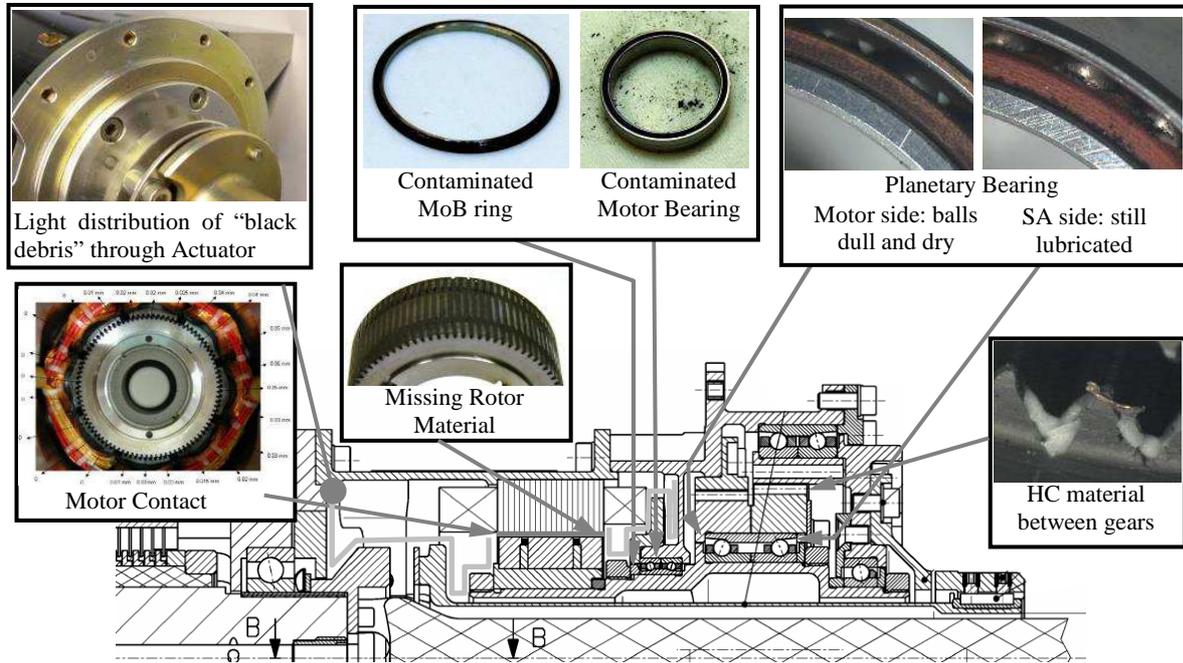
Figure 1: Pictures of Disassembled SAD-LP components and Key Findings.

During the disassembly the following issues were discovered which are summarised on figures 1 and 2.

- There had been contact between the motor rotor and stator.
- There were extensive deposits of dry black particles on the motor.
- Wet particles were distributed throughout the actuator which could be attracted by a magnet.
- The bearing nearest to the motor (MoB) was highly contaminated with black particles & was dry. The bearing ring was highly

- contaminated with dry black particles which were 'fused' together.
- The next bearing in the chain was dry on the motor side and far less contaminated on the other side.

- Lubricant on the other bearings and the gears was in good condition as was the creep barrier.

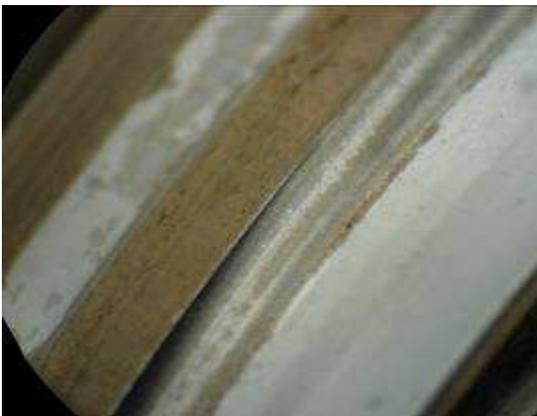
Figure 3: Inner Raceways

The inner raceways were dull, 'pitted' and this extended to the dams. Contact marks from cage riding were seen on the land. One raceway track was uneven due to axial loading.

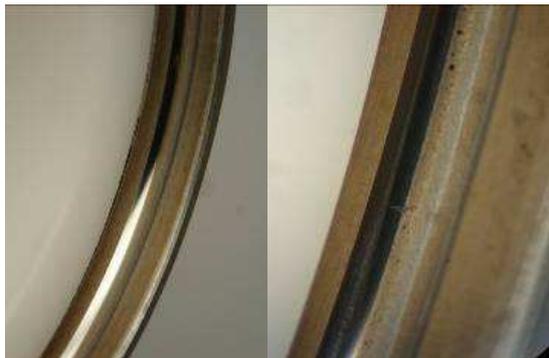
Figure 4: Outer Raceways

There was also some noticeable 'damage' in the form of contact marks from cage on the land. There was a change in the circularity of the bearing of about 8µm which was due to the applied loads.

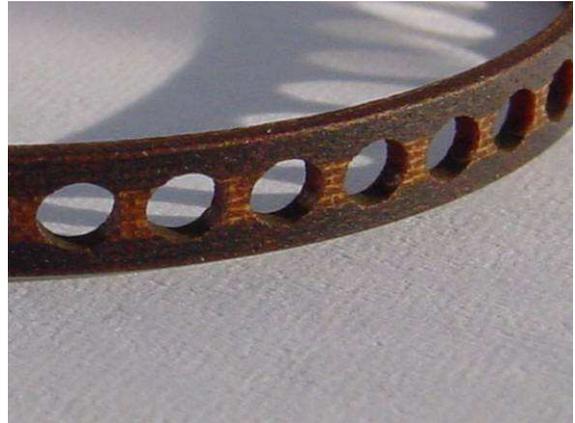
Figure 5: Phenolic Cages

The cage was dry, i.e. no lubrication was present. There were marks on ball pockets and rubbing marks on ID & OD.

The main issue arising from these findings was the contamination and the lack of grease present in the bearing. An SEM and EDX analysis was made on both the cage and the ring of the bearing to determine the chemical breakdown of the materials present on the bearing.

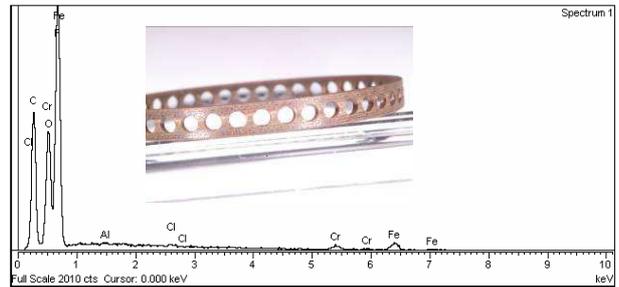
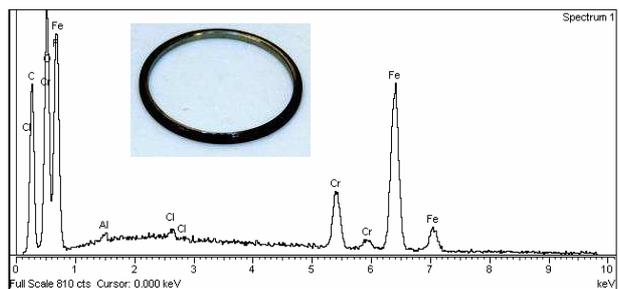
Figure 6: Results from SEM Micrograph and EDX analysis.

Figure 1 SEM micrograph and corresponding EDX spectrum from cage 1. The purple rectangle identifies the region for EDX analysis.

Figure 2 SEM micrograph and corresponding EDX spectrum from ring 1. The purple rectangle identifies the region for EDX analysis.

The results showed no evidence of Soft Iron from the motor (Vacoflux: Fe, Co, V, Ni) at the motor stator interface but there was evidence of the rotor potting material (Stycast epoxy: C, H) within the bearing contamination material and also evidence of the Braycote 601EF grease (C, F, H & PTFE).

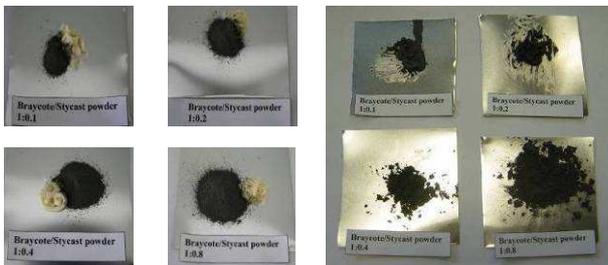
Samples before mixing Samples after mixing
Figure 7: Stycast / Braycote Absorption Test

It was possible to reproduce the initial reaction between the two materials where they form a cake substance (or 'crumbs') but they did not form an emulsion and there was no further reaction between the materials.

Apart from the moisture loss on the bearing, there was no measurable weight loss of the braycote. The braycote was however fully absorbed by the staycast which leads to a loss in the effectiveness of the braycote which may lead to the bearings will tend to wear quicker. It is apparent that a small quantity of stycast can cause increased wear in the bearing when mixed with the braycote.

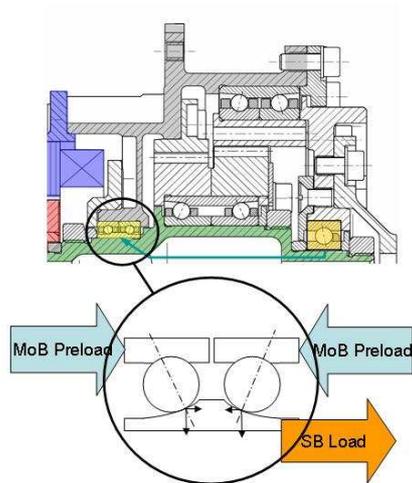
Figure 8: Eccentric Preload on Bearings

From a careful examination of the bearing configuration, it was established that the preloading of the shaft bearing acts as an external load on the motor bearing and affects the applied preload within the bearing. The effect of this is shown on figure 8.

This effect leads to a change in stiffness of the MoB which means that the bearing off loads earlier than anticipated during the vibration testing.

Lesson Learnt 1: It may seem obvious but check for internal design effects that for example may cause a redistribution of the preload in bearings which could in turn lead to a change in bearing stiffness.

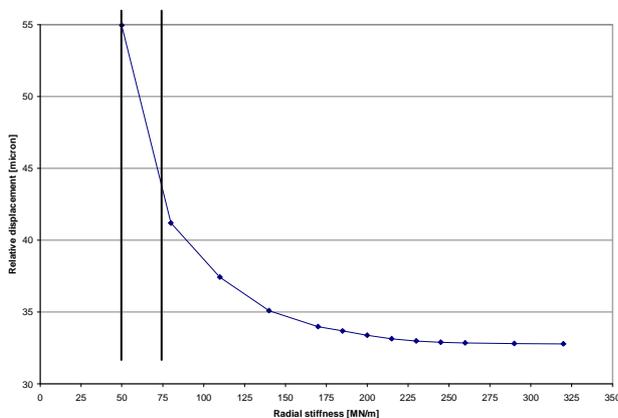
Figure 9: Displacement Increase as Result of Stiffness Variation on Motor Bearing

The displacement on the bearing due to the stiffness variations is shown on figure 9.

Here it can be seen that as the stiffness decreases, the displacement increases significantly.

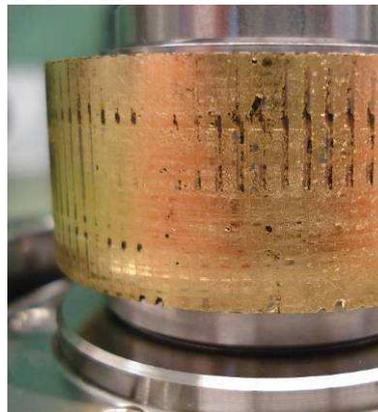
Figure 10: Gold Coated Rotor showing contact marking

After the test, the mechanism was disassembled to determine whether or not there had been contact between the rotor and stator. Despite the lower vibration levels, marks were seen on the gold coated motor which indicates that the rotor and stator have made contact with each other.

These marks, seen on figure 10, can be differentiated from those that occur during disassembly because these would show as scratches while the contact marks in question are clearly 'imprinted' in the soft layer. The undisturbed surface with the rotor structure shining through can also still be seen.

The results from the test verified the assumptions that the bearing stiffness changed during the test causing displacement at the bearing causing the motor to contact.

Lesson Learn 2: Account for the variable bearing stiffness when loaded externally (i.e. Vibration) to

account for bearing deflection and loads. This effect can be significant.

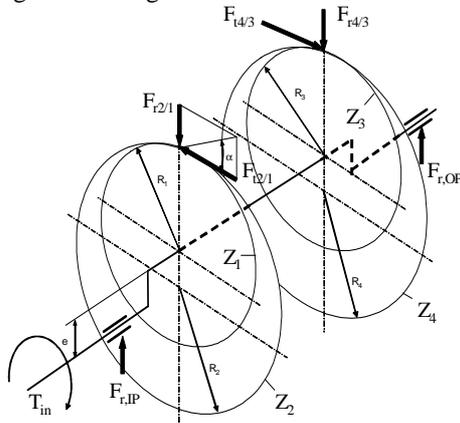
Figure 11: Bearing Forces due to Gear eccentricity

When a load is applied at the output flange of the SAD-LP, this translates into a radial force on the motor bearing due to the gears as shown below:

If a load of 20Nm is applied to the output flange of the mechanism, the result is a radial load of 425N acting at the Motor Bearing. During the life test, there was a long phase where the mechanism was driven at 0.5°/s with a large inertia attached to the output flange. This led to a higher than normal load at the output flange but this still only corresponded to a moment at the output shaft of only 1Nm. This results in a load at the motor bearing of only 22.6N which is considered insignificant and therefore has no significant impact on the bearing allowable life. The load issue on the gears is reinforced by the inspection where it was seen that there was no noticeable wear.

Lesson Learnt 5: When using a fixed output inertia to simulate external loads, the speed of operation of the mechanism should be considered as higher speeds to accelerate testing may lead to higher than expected loads on the mechanism.

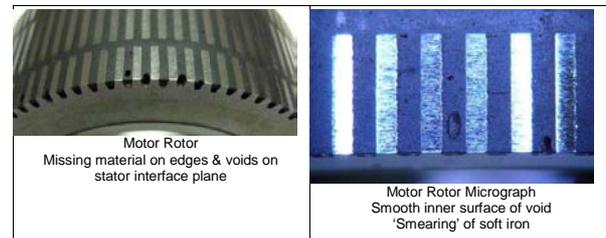
Figure 12: Voids on Motor

From an examination of the rotor surface, it was seen that there were a number of voids in the Stycast. After discussing this issue with the supplier, ETEL SA, it was clear that the voids occurred because the resin was not degassed during preparation. Without degassing of the resin, the machining operation can leave very thin areas over the voids which when placed in vacuum could break off and migrate towards the bearing and then break up into a powder form and react with the Braycote.

These voids are shown on figure 12.

Based on the experience of working with Stycast available within OSZ, it is unlikely that the contamination originated in this manner.

Lesson Learn 6: When using resin materials, always ensure that the mixture is degassed before use to remove air bubbles.

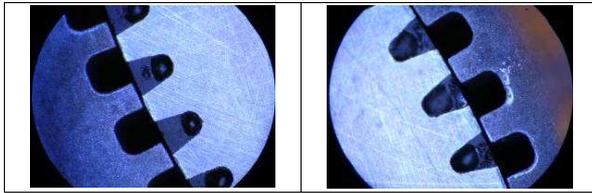
Figure 13: Gap between Rotor (lighter colour) and Stator of SAD-LP Rebuild

Prior to the retest on the mechanism to demonstrate that contact occurred at the motor, the gap was measured between 54 μm and 58 μm which indicates a good build standard for the unit.

This gap is shown on figure 13.
