PROBLEMS ENCOUNTERED DURING THE RECERTIFICATION OF THE GLORY SOLAR ARRAY DUAL AXIS GIMBAL DRIVE ACTUATORS

Marc Saltzman⁽¹⁾, Joseph P. Schepis⁽²⁾, Michael J. Bruckner⁽³⁾

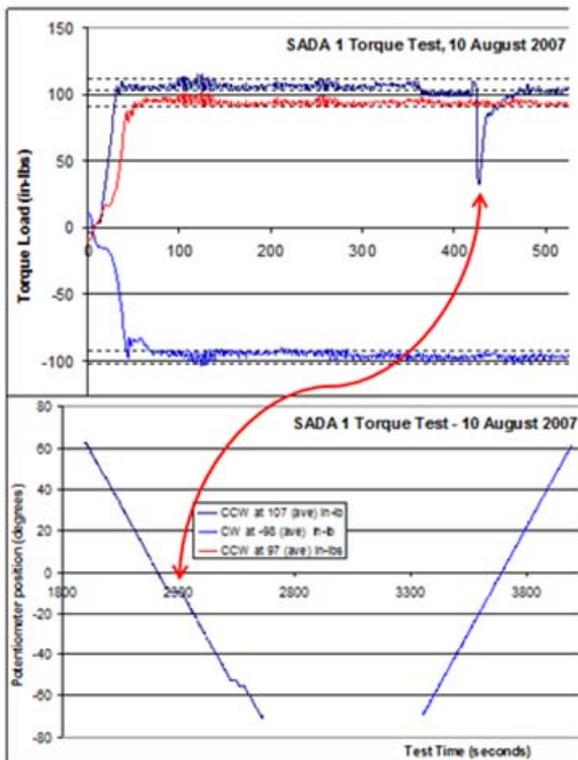
Figure 4 Torque Test Data

Torque capability in the 150 in-lb to 190 in-lb (16.9 N-m to 21.5 N-m) range was produced prior to shipment but, as demonstrated by the plots in Fig. 4, there was either 30% degradation in torque or a serious flaw existed in the test apparatus. At least two days were spent checking the calibration of the torque test setup. The final test results for both SADAs are shown in Tab. 2. In this table, “N/A” indicates the configuration could not be tested without disassembly.

loss changes on the order of 30%. This mysterious torque loss was very perplexing. Moog was contacted to validate our torque testing approach, and they did validate it. Despite test setup confirmation indicating our torque measurement approach was not flawed, the sentiment at the time was that something was amiss with the setup and that the SADAs were, most likely, acceptable. A large contributor to this sentiment was the fact that the threshold voltage measurements were very reassuring. Nevertheless, NASA and Orbital agreed to follow the logic flow of our recertification decision tree and send the units back to Moog for a set of confirmation tests. At the time, it was assumed that some detail of the test setup or apparatus was flawed and that the inconsistency between the threshold test data and the torque test data would be resolved when Moog retested the actuators using the original test equipment.

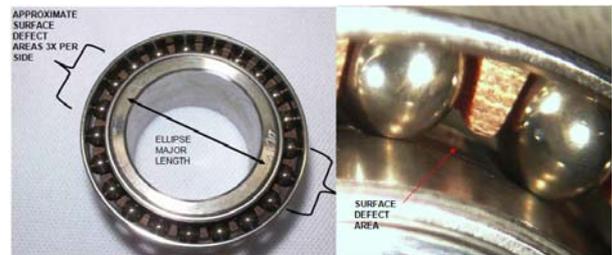
Figure 9 Harmonic Drive Wave Generator Bearing with Defect Areas

- The alpha drive showed no degradation from 1999.
- The beta drive showed the 30% to 40% degradation measured by Orbital.
- The SADA 1 motor stator housing was removed allowing the rotor/harmonic wave generator to remain installed. Moog observed that rotor rotation was ‘lumpy’ with repetitive cyclic torque peaks of approximately 6.5 inch-ounces (45.9 mN-m) versus the Moog

requirement for new hardware of 2 inch-ounces (14 mN-m).

- There remained a good quantity of grease/oil slurry present in the wave generator bearing.
- The amber colored lubricant inside the harmonic drive wave generator bearing was somewhat darker in places than the shade for new lubricant (50% Pennzane oil & 50% Pennzane grease).
- The cleaned wave generator bearing races had small patches of discoloration with a grainy appearance from either embedded material or a divot. These are shown in Fig. 9. Three such patches on each side were located on the inner race at the major diameter areas and coincided with the spacing of the balls. The remaining portions of the races were clean and smooth. An attempt was made to mechanically remove the discoloration using a pointed plastic stick but this was not successful.

SADA 2 was returned to Moog and retested on 1/30/2008. The beta drive showed 20% to 30% output torque degradation. The beta actuator was disassembled and showed the same discolored areas shown in Fig. 9, but not quite as prominently. Prior to disassembly the actuators were subjected to both threshold voltage and torque testing for comparison with the results recorded earlier by Orbital. These results also placed in question the validity of using threshold voltage testing as a conclusive verification that all is well with an actuator.

At this point the flow path led NASA, Orbital and Moog to the decision to disassemble the wave generator bearings from the beta actuators and subject the races and balls to laboratory testing. After two separate investigative sessions at Seal Laboratories, Moog’s assessment was that the discolored areas were, in fact, pitted areas most likely due to stress corrosion. Fig. 10 shows a visual summary of the typical findings. Except for a very minor amount of discoloration observed on the alpha actuator of S/N 1, the alpha

Based on the aforementioned findings, Orbital revised the Moog service agreement to include complete replacement of all harmonic drive bearings in both SADAs 1 & 2. While not contributing to the degradation the cotton phenolic wave generator bearing retainers were vacuum impregnated using an extended time of 3 days as recommended by the NASA

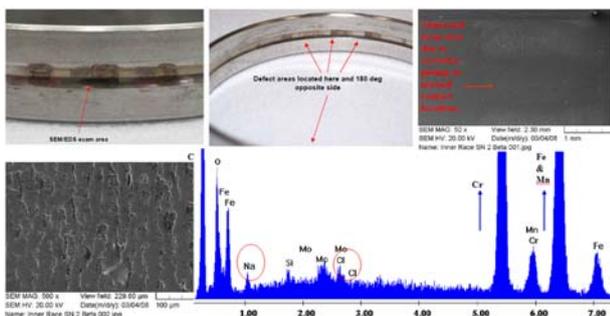
Figure 10 Laboratory Investigation Findings

Moog determined that the harmonic drive supplier had used a chlorinated solvent as part of the cleaning process. This practice has long since been prohibited but at the time the VCL SADA components were manufactured the process was still in use. It is thought that some small amount of this solvent had not been fully washed away. This in combination with the presence of sodium in the grease thickener provided the constituents for a salt solution only awaiting the arrival of small amounts of water vapor, the presence of oxygen, and, lastly, the availability of lots of time for the corrosion process to attack the bearing surfaces under most stress. The elliptical wave generator plug provided the stress. The evidence for the presence of chlorine and sodium is shown in the electron dispersion spectrographic (EDS) analysis portion of Fig. 10. Until 2004, the SADAs were stored with the VCL bus bagged and with an N2 cover gas but it was never confirmed that the cover gas had not dissipated, that the bag was entirely leak tight, or that trace amounts of moisture did not exist in the purge gas. In addition, after 2004, the SADAs were exposed to the atmosphere as they were required for integration and test purposes. There remains the mystery as to why the alpha actuators were not nearly as degraded as the beta actuators. Nevertheless, the root cause was concluded to be stress corrosion due to the incomplete cleaning of the harmonic drive components leading to the presence of small amounts of chlorine, sodium, water vapor, oxygen, and lots and lots of time.
