LIFE TEST OF THE SCARAB INSTRUMENT SLIPRING UNITS

ABSTRACT

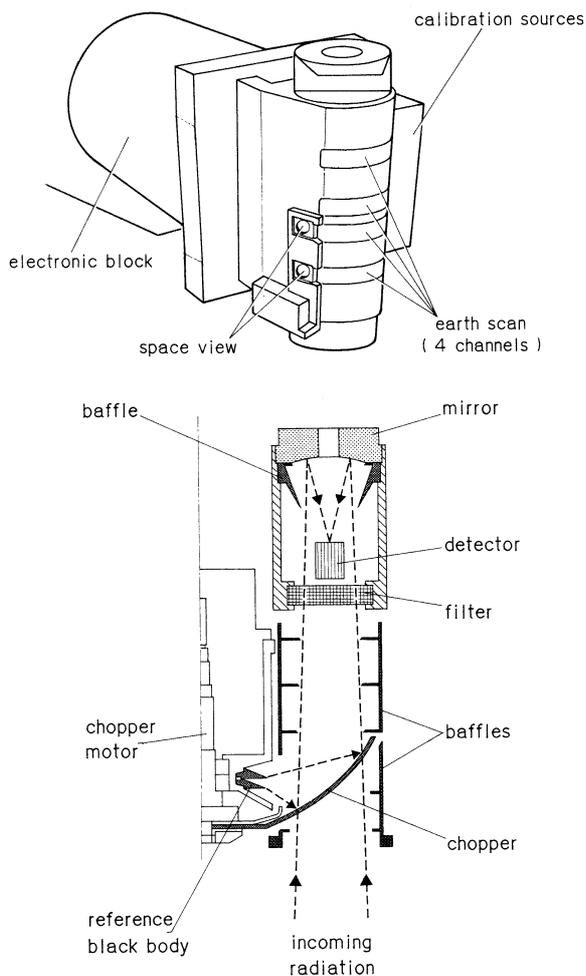
FIG. 1. Sketch of the ScaRaB instrument (upper), details of telescopes (lower).

The Laboratoire de Météorologie Dynamique (LMD) developed the SCARAB instrument. It is a cross-track scanner with a spatial resolution of 60 km × 60 km. The earth-scanning angle covers 100°, which corresponds to a 1600-km swath width on the ground. The instrument consists of four telescopes (spectral channels). Two of them are broadband channels: channel #2 covers the solar reflective domain (0.2 μm to 4 μm) and channel #3 operates over the whole spectrum (0.2 μm to 50 μm). The others are narrow-band channels: channel #1 (0.5 μm to 0.7 μm) and channel #4 (10.5 μm to 12.5 μm). These are used to check that the observed scene can be identified. The ERB parameters are obtained by combining the measurements of channels #3 and #2, and the outgoing thermal radiation is computed from the difference of both measurements. The telescopes are located in a rotating, cylindrical scan head (Fig.2). The outer skin of the scan head is fitted with openings used for earth viewing and space-based calibration. The optics consists of one spherical mirror for each channel, which focuses the beam onto a pyroelectric detector (Fig.1). The radiation arriving on each detector is chopped at the pixel sampling frequency. To do this, a short-wave chopper (sw/c) covers channels #1 and #2 and a long-wave chopper (lw/c) channels #3 and #4 (Fig.2). Each chopper consists of a rotating hemispherical mirror fitted with two openings. Hence, each detector alternately receives radiation directly from outside and radiation reflected from a small reference blackbody (Fig1).

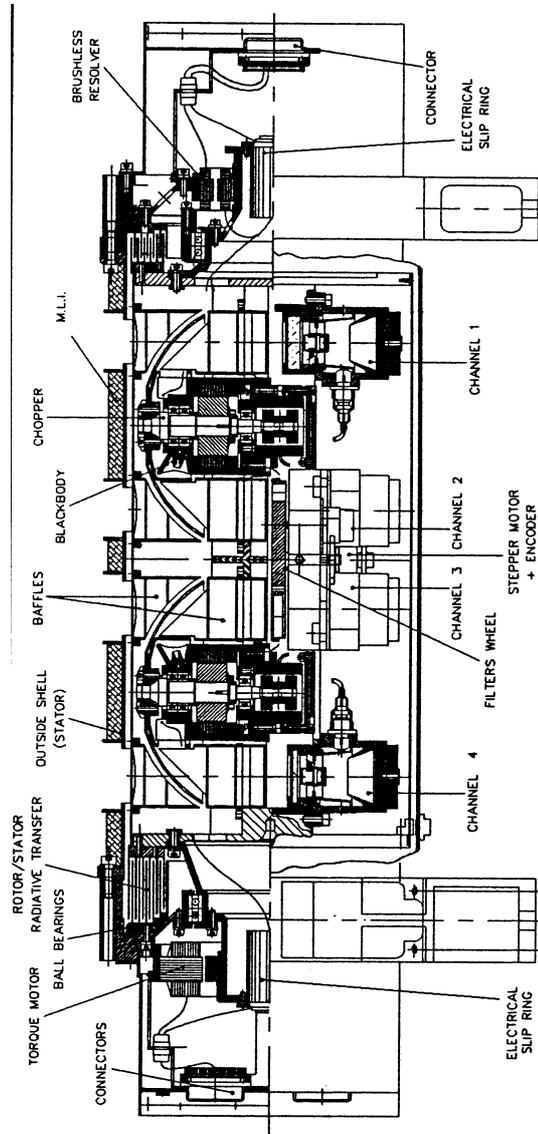
FIGURE 2 - OPTICAL HEAD DESIGN

The optical head is a mechanical system that comprises four telescopes and the relevant data processing electronics, two choppers and one f/wheel. All the equipment is mounted on a rotating shaft, which is supported by two pairs of angular contact ball bearings (Fig.2). The choppers rotate continuously at an 8 Hz speed rate for 2 years ($500 \cdot 10^6$ cycles). The f/wheel is driven by a stepper motor associated to an 8:1-rate gear speed reducer. Compared to the choppers, this motor has to rotate far less because it is used only during the different instrument calibration modes. The entire optical head bearing lubrication is dry coated with MoS_2 -filled cages or spacers essentially to prevent optics pollution. These mechanisms are all located on a shaft, which moves in unlimited rotation. Here, two slipring units are needed to transmit the electric signals. For design reasons, they were implemented one at each end

of the main shaft (Fig.2). The resolver-side one (r/s) transfers the digitised and multiplexed measurement data as well as the f/wheel round sensor signal. With the motor-side one (m/s), the choppers angular sensor signals and the main shaft resolver signals are transferred to an outer static electronic block.

In addition, this unit transmits the power supply of the choppers and f/wheel motors. Each unit comprises 36 tracks rated at 500 mA. The maximum current value encountered in flight is 100 mA. The sliprings consist of gold alloy solid rings and single wire brushes. The slipring rotor rotating guidance is provided by a couple of MoS_2 -lubricated bearings. The slipring units were manufactured and supplied by MECANEX.

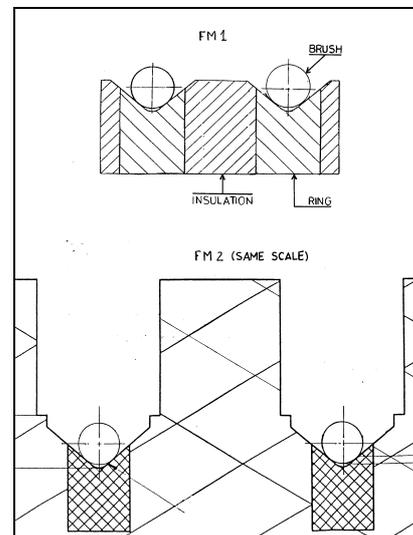
Figure 3 – Shape evolution between FM1 and FM2 slirings

One main point was analysed on the slirings: the insulation gap between the tracks. Figure 3 shows a cross section of the slirings pattern. From FM1 to FM2, the only change was the insulation material shape between the rings. The reason for this was to increase the gap between two adjacent tracks as much as possible, and still meet the size requirement. The same FM1 materials were used for FM2.

The FM1 slirring units had been selected as on the shelf components not designed for a space application. The device analysis focused on the bearings and the slirings. The FM1 rotor guidance configuration consisted of two bearings of different sizes. Stress analysis showed that the vibration loads applied to the unit were likely to over-stress the smaller bearing, and not the larger one. This is why a new configuration was adopted with two identical bearings. Another problem we faced was the bearing preload. In the FM1 design, a screw acting directly on the small bearing inner race (O mounting) gave a solid preload. As a result, the unit could tolerate no thermal expansion. Moreover, the preload value could not be accurately controlled at integration level. Thus, it was decided to set a soft preload obtained by elastic washer deflection. So, the bearing preload value was adjustable and could be checked on every flight model. The last bearing change regarded the lubrication. On the FM1, the lubrication solution was based on both TiC-coated balls and an MoS₂ spray deposit, which is not qualified for space use. This process could not guarantee either the lubricant amount control or whether it would remain in the bearings. This is why a PVD MoS₂ coating on the tracks was chosen for FM2. A Duroid 5813 cage replaced the FM1 bearing metallic cage and flanges were added to each FM2 bearing to prevent wear particles from migrating towards the electrical tracks.

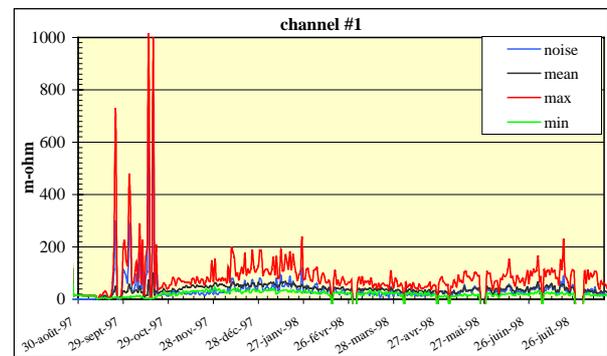
Figure 4 – one-track impedance – test first year

Figure 4 shows two separate phases. The first one covers the first couple of months of the test. At start up, the mean impedance value stood up at 15 mΩ, and the impedance noise was about 1 mΩ. After this very quiet phase, some interference appeared in the contacts and remained for more than one month, as the max and the noise curves attest. A great amount of wear particles may have been generated within a short period of time. This probably created difficult brush sliding conditions.

Disturbances may have disappeared when the early wear particles were removed from the tracks or began to collect on the brush. This phenomenon could be considered as a run-in process. During this phase, the mean impedance remained relatively low at 40 mΩ. The disturbances exhibited high values but in a limited number of occurrence.

The second phase spread over almost two years. During this period, the sliding contacts cumulated nearly 10 millions turns. Their electrical performance was relatively stable, revealing healthy sliprings. The mean impedance value oscillated at around 50 mΩ, and the noise level remained below 40 mΩ. At this point of the test (mission completion), the electrical performance still met the requirements.

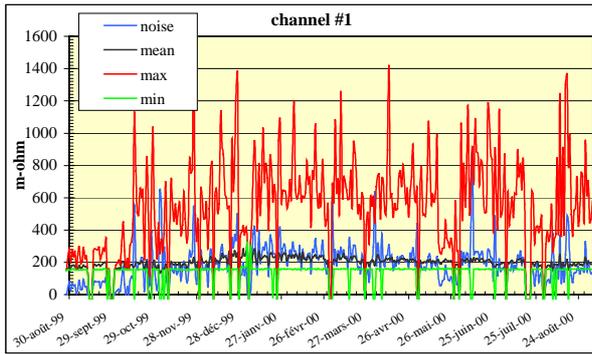
Figure 5 – one-track impedance -test last year

A significant change in behaviour can be seen in figure 5, which shows the last year of the test. The contact sliding distance of that period of time is equivalent to 5 million turns. In mid-1999, the mean impedance had risen up to 180 mΩ. At that time, the noise level had slightly increased to roughly 60 mΩ. Then, in mid-October 1999, the max values suddenly increased, revealing new interference in the brush-track contacts. These degraded sliding conditions remained until the end of the test. Nevertheless, the mean impedance stopped increasing at 220 mΩ, by the end of 1999 and even decreased steadily for the last six months of the life test. The electrical noise closely followed the same evolution. In addition, the min values were very similar to the mean ones. This indicates that a relatively poor number of high values were part of the measurement sampling. The presence of wear particles in the contact may have been responsible for the contact impedance degradation, as the sliprings had not yet been worn out. The final values of the test are 180 mΩ for the mean impedance and 150 mΩ for the noise level. The mean impedance was multiplied by 5 since the beginning of the test. A noise level of 22% 0-peak of the total 8-track group impedance was noted.

Examining the tested tracks' results, one interesting feature was identified. The sliding distance does not systematically affect the contact impedance degradation. In fact, the contact disturbance slump may even occur far from the run-in phase.

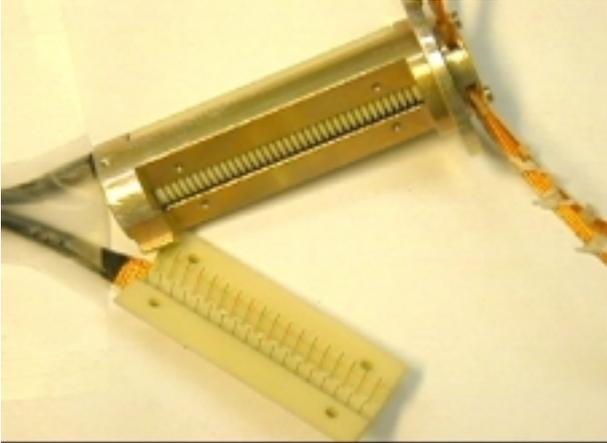
Figure 6 – overview of one slipping unit

After the qualification life test, the two slipping-units were dismantled from the equipment. One was sent back to the supplier MECANEX and the other one stayed at CNES. Both were subjected to a detailed inspection. Figure 6 shows an overview of the unit inspected at CNES.

The light coloured part is one of the two brush-supports. It is removed from the slipping housing. No apparent damage could be seen on the brushes. A large number of tiny golden particles were observable on the support surface. The shaft and the tracks are partially visible through a housing aperture. By naked eye observation, it was not possible to identify any track unexpected wear or any insulation defect.

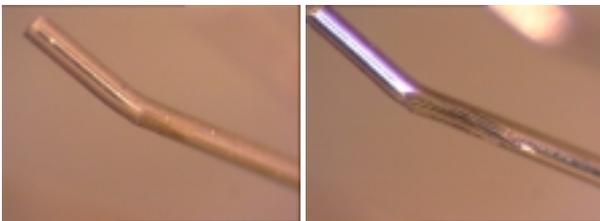
Figure 7 – brush contact area

On figure 7, we can see two brushes from the same brush support. On the right side, the brush exhibits a large contact area. This area is located just before the brush bent end. This particular shape is designed for brush mounting easiness. The contact curved shape is the result of brush friction on the track. Inside the contact zone, sliding lines have been grooved along the motion direction. At contact outlet, accumulated wear particles remain glued onto the brush. This is even more visible on figure 8.

On the left side of figure 7, almost the same can be observed. However, a difference is the contact area size. This brush is obviously less used than the other one. This could be the result of a lower preload. Among all the brushes, the inspection revealed a very scattered wear rate. The above right side brush is one of the most

worn brushes. In this case, the material removed volume is less than the third of the original size.

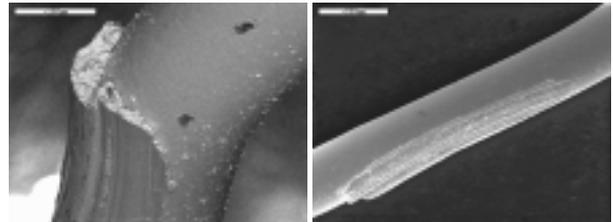
Figure 8 – brush SEM viewing

Obtained by SEM analysis, figure 8 shows the material shifting inside the contact area as well as the friction lines. The brushes are coated with tiny metallic debris of typically a few microns size. The brush contact surface X-analysis revealed that the track material was present. A part of the wear particles from both track and brush has collected onto the brush.

Troughout lifespan, some gold alloy was removed from the track and gathered by the brushes. The picture also shows the typical shape difference between the inlet and the outlet contact area.

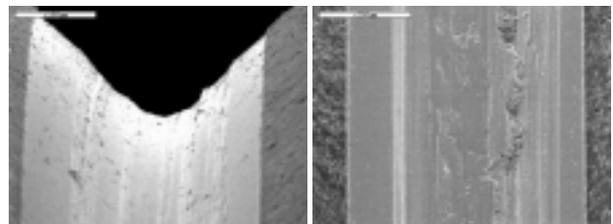
Figure 9 – typical track pictures

Figure 9 shows a typical track EOL shape by SEM viewing. On the left side, the track is side viewed. The light part of the picture represents the metallic ring and the dark one is the inter-ring insulation. The sliding track is the worn part of the ring located in the center of the picture. The brush shape has been grooved at the bottom of the track. Very little metallic debris of typically a few microns size was found all over the ring.

On the right side, the track is front viewed. At the bottom of the track, wear particles have been laminated between the brush and the track, and even pushed away from the track. The tracks do not seem to be excessively worn out regarding the large number of performed rotations. Among the rings observed, no bearing particles could be found. This means that bearing flange confined the wear particles throughout the test.

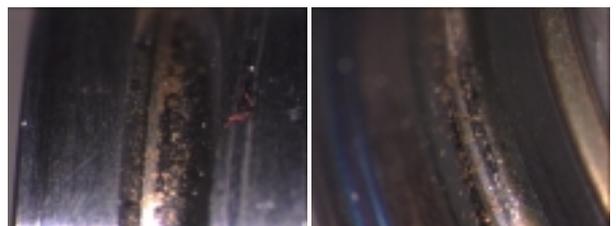
Figure 10 – bearing inner and outer race

Figure 10 shows the pictures of the inner and outer race of one unit bearing.

On the left side, in the center, we can see the rolling track of the inner race. The black part represents the MoS_2 coating. X-analysis showed that this coating is in the same state as it was at the origine. It has only been partially removed from the track, leaving a white narrow stripe that is located on the ball rolling path. We can notice that a large number of golden particles are spreaded all over the track. These particles have been flattened out by the balls and now remain glued on the track. All this golden debris certainly came from the slipping part of the unit. This did not prevent the bearing from working well. The same inner race observations are valid for the outer race, which is displayed on the right side of figure 10.

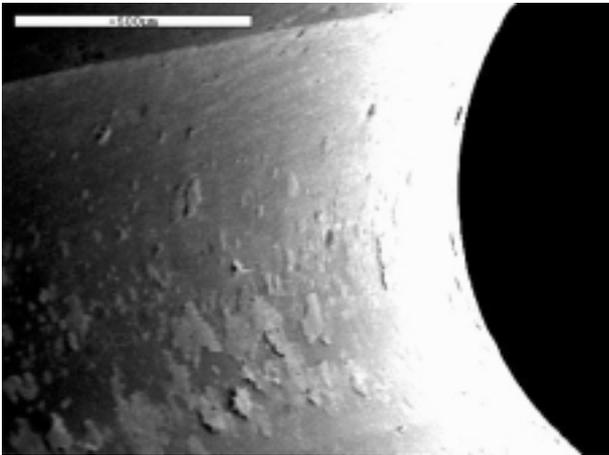
Figure 11 – bearing inner race

Figure 11 shows a more detailed view of the bearing inner race obtained by SEM analysis. The ball rolling path is not visible. This means that no direct ball to race steel interaction was experienced during the test. The bearing EOL capacity is still not reached.

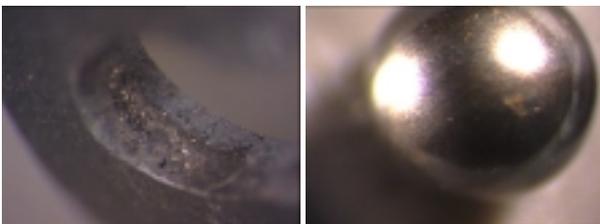
Figure 12 – bearing cage and ball

Figure 12 shows on the left side a Duroïd 5813 cage alveole and, on the right side, one typical bearing ball. We can notice that the ball left marks on the cage alveole. These ones are located in the middle of the cage thickness. Again, golden debris were trapped between the ball and its alveole. The cage wear rate seems very poor. This may be related to the moderate designed bearing preload.

A thin MoS_2 film coats all the bearing balls. As the balls were not initially coated, this could be essentially caused by the race MoS_2 removal. Any marks could not be found on the balls.
