Development and Acceptance Testing of the Dual Wheel Mechanism for the Tunable Filter Imager Cryogenic Instrument on the JWST

Martin Leckie* and Zakir Ahmad

Abstract

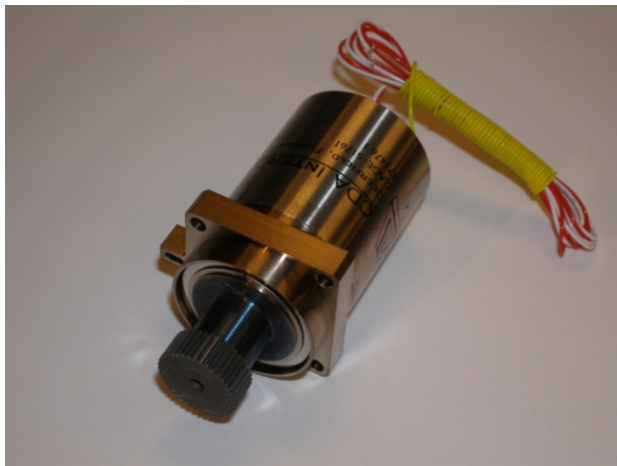
Figure 5. Geared Motor – Pupil Wheel

The actuation to rotate each wheel is provided by a geared motor. The geared motor is a combination of a three phase stepper motor (step size of 15 deg.) and a single stage planetary gear. The geared motor for the PW is shown in Figure 5.

The first round of room temperature testing yielded a pull in torque value of 17 N-cm versus a specified requirement of 23 N-cm. This was thought to be a simple shortfall in motor performance and certainly not a design problem. It was decided to proceed to cryogenic temperature testing. The testing at cryogenic temperatures was carried out in a cryogenic chamber together with a feed thru shaft out of the chamber coupled to a torque measurement machine.

The first test at 35K did not result in full rotation of the motor. The motor exhibited some stalling and an investigation was started through the material review board process. Considering the observations, the motor performance appeared normal at room temperature, but the performance at 35K was abnormal. The cause was immediately thought to be a deficiency in the motor and that the cryogenic environment must be causing more friction in the motor bearings and planetary gears.
