TEST & INSPECTION CAMPAIGN OF SURREY SATELLITE TECHNOLOGY LTD FIRST GEOSTATIONARY WHEEL

This paper will discuss the test and inspection campaign of the Actuator Confidence Model (ACM) wheel, the challenges of obtaining the required level of confidence for a mechanism that is required to operate successfully in excess of 15 years and the resultant conclusions and lessons learnt/recommendations for future.

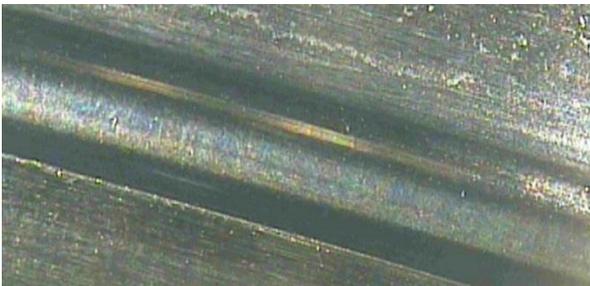
Figure 16. Bearing race showing running track

The ACM bearing inspection was carried out at ESTL by SSTL, ESTL and ESA. Both bearings were in good condition with no evidence of marks on the bore or on the outer diameter. No oil meniscus was observed between the cage and land indicating that although oil was present in the bearing, there was not sufficient quantity to bridge the gap between lands and cage. The ball bearings were disassembled and the component parts were examined using a low power microscope and a digital microscope. The bearing raceways were in good condition and the ball running track was evident as a slightly dulled or frosted region just off the center of the ball groove as shown in Figure 16. The balls show a visible orbital track as shown in Figure 17, suggesting the ball spin axis is generally constant and

not prone to problems such as skidding leading to multiple orbital bands. Significant oil was still present on the raceway and lands. No evidence of misalignment or variations in width or position of the ball track was observed. The running tracks were parallel to the ball groove and were of even width, as expected for a bearing which operated without misalignment or other anomalies. From bearing analysis, the semi-major axis at the ball to inner race contact was 0.16mm. On this basis, the ball track can be expected to be 0.32mm. Although this prediction was less than the maximum estimated track width measurement of 0.5mm, the track could be wider if we consider thermal effects and axial movement causing small variations in track position. Note that it would require a thermal gradient of 12°C to increase the effective preload such that the contact ellipse semi-major axis was 0.25mm. A thermal gradient of this magnitude is unlikely in fluid lubricated ball bearings. Therefore, contributions from variations in axial ball positions during operation could also result in widening of the ball track. We could expect some degree of axial movement due to variations in ball loading (wider track if some balls more heavily loaded). In addition, micro pitting could result in some steel particles mixing with the oil and being pushed to the side of the ball-raceway oil meniscus and being deposited as a fine brown band outside the contact ellipse, giving the impression of a wider ball track than analytically predicted.

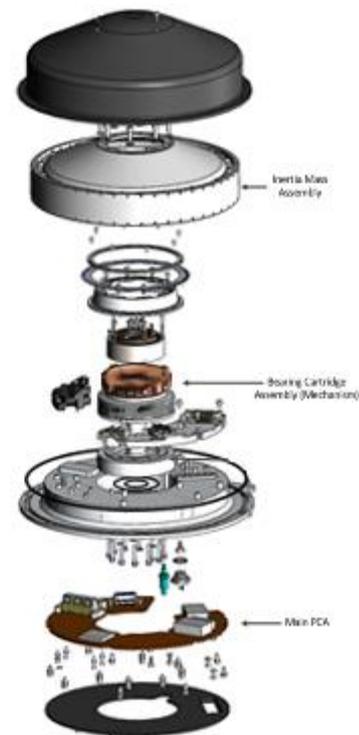
Figure 19. SSSL's First Generation Geo Wheel

Although not discussed in this paper it is useful to summarise the final wheel design (EQM/FM) which has further evolved by SSSL from the Actuator Confidence Model (ACM) and significantly (except mechanism) from the LTM. This is shown in Figure 19. Since the LTM, the redesigned structure now separates the mechanism completely from the main electronics in its own vacuum (during ground testing also) whilst taking up less mass and volume. The wheel incorporates its own internal Class 1 radiation hard drive electronics and FPGA that provides a full range of telemetry and automation as well as a bespoke motor and encoder. The rotor part of the motor is directly connected to a mechanical structure which is supported by a series of bearings to allow rotation, whilst the stator remains fixed. In turn the rotor is connected to an inertia mass (effectively a flywheel) which spins up to ± 5000 rpm. Speed feedback is either via hall sensors or via an optical encoder which gives more accurate feedback. As with all SSSL wheels during deceleration they act as a generator and sent power back to the spacecraft bus.
