BEAGLE 2 - A RETROSPECTIVE LOOK AT THE BEAGLE 2 LANDER MECHANISMS FOLLOWING EVIDENCE OF SUCCESSFUL DEPLOYMENT

Paul McMahon⁽¹⁾, Richard Slade⁽²⁾, Jim Clemmet⁽³⁾

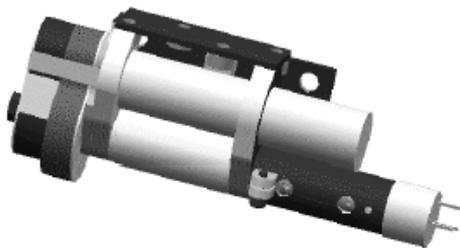
light and the mechanism only had to cope with a single possible deployment orientation of the Lander. All 4 mechanisms were essentially identical but with slight geometric differences in the output flange to account for the way the 4 panels were stacked upon each other. The SAHMs consisted of a motor gearbox assembly and single pass spur gear set with a 3729:1 gear ratio plus structural interfaces to the Lander lid and the SA panels. With a deployment time of approximately 12 seconds for the full 180 degrees rotation the mechanisms had to be deployed in a specific sequence and time controlled to avoid clashes with other panels. The panels had to be rotated through at least 100 degrees to provide sufficient room for the next panel to deploy.

Figure 4: SAHM Mechanism

At this point it is worth comparing the difference in mass between the MHDM and the SAHM. Each SAHM weighed only 120 grams compared with 987 grams for the MHDM, which reflects reasonably well the difference in work required from the different mechanisms. The SA panels weighed around 0.750 kg each whereas, as stated, the MHDM had to potentially deploy the base and equipment within, which weighed 24.3 kg.

As with the MHDM there was no redundancy built into these mechanisms, constraints on available space and mass meant that the normal practice of having redundant motor coils could not be implemented. The SAHM used a different Maxon motor/gearbox assembly so a redundant coil would have added at least another 25 grams per hinge plus the impact of additional wiring and circuitry, plus any additional support structure to support the increased length of the cantilevered motor.

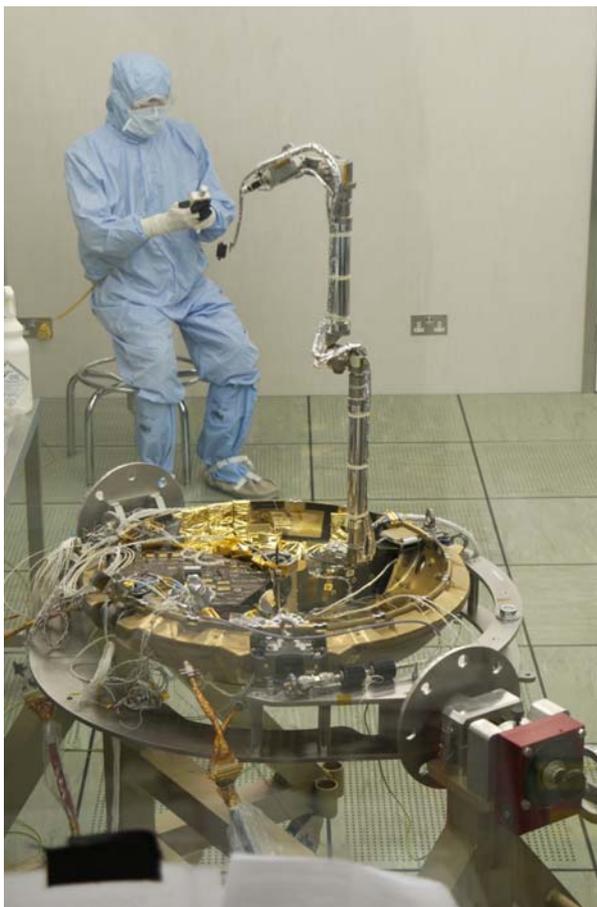
Figure 6: Instrument Arm Assembled in Lander
