# Suomi-NPP Mission On-orbit Experience with Toroid Ball Bearing Retainers under Unidirectional and Reversing Motion

Otto Bruegman\*, Kamal Thakore\*\*, Stu Loewenthal+ and John Cymerman\*\*

## Abstract

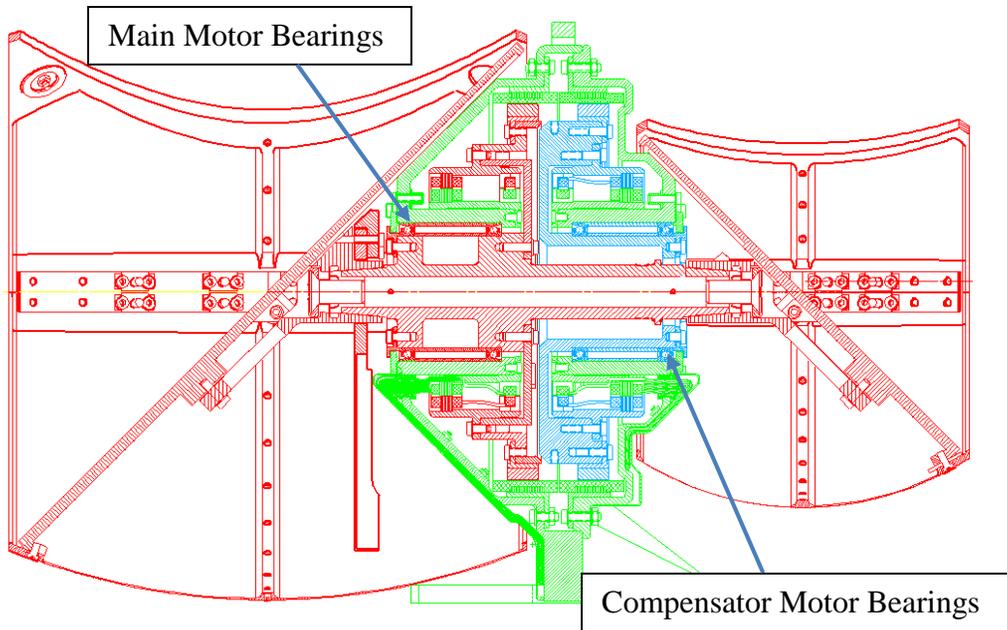
**Figure 1. ATMS Scanner Cross-Section**

Figure 1 depicts the scan mechanism in cross section, which identifies the major components of the assembly. Note that there are two sets of bearings in this assembly. The problem is only observable with the Main Motor bearings for ATMS. The Compensator Motor bearings are identical to the Main Motor bearings, but run at a rate of 1.8X the Main Motor rotation rate and have not shown any misbehavior. At this time, we don't know why the Compensator Motor bearings are acting differently than the Main Motor bearings.

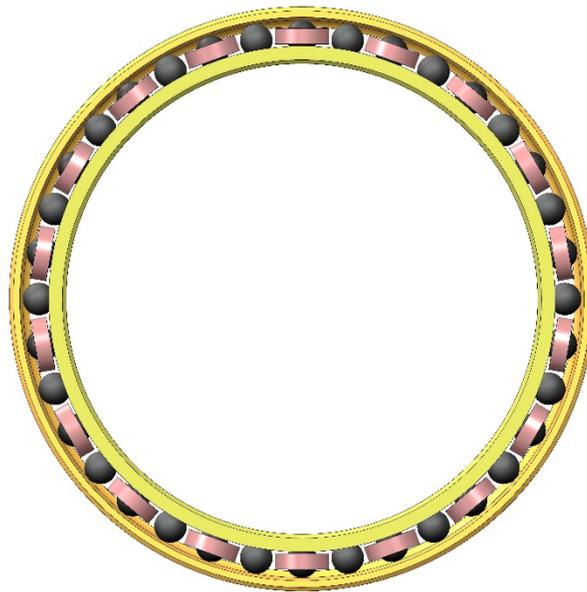
**Figure 2. Nominal ATMS Bearing Configuration**

Figure 2 depicts the bearings in question, showing the arrangement of the balls and the retainers. The bearings are an angular contact pair manufactured by Timken. The bearing pairs have an OD of 57.15 mm (2.0 inches), with each bearing having a complement of 38 3.175-mm (0.125-inch) balls and 19 toroids. The nominal contact angle is 20 deg. Bearing preload is 44.5 newtons (10 pounds).

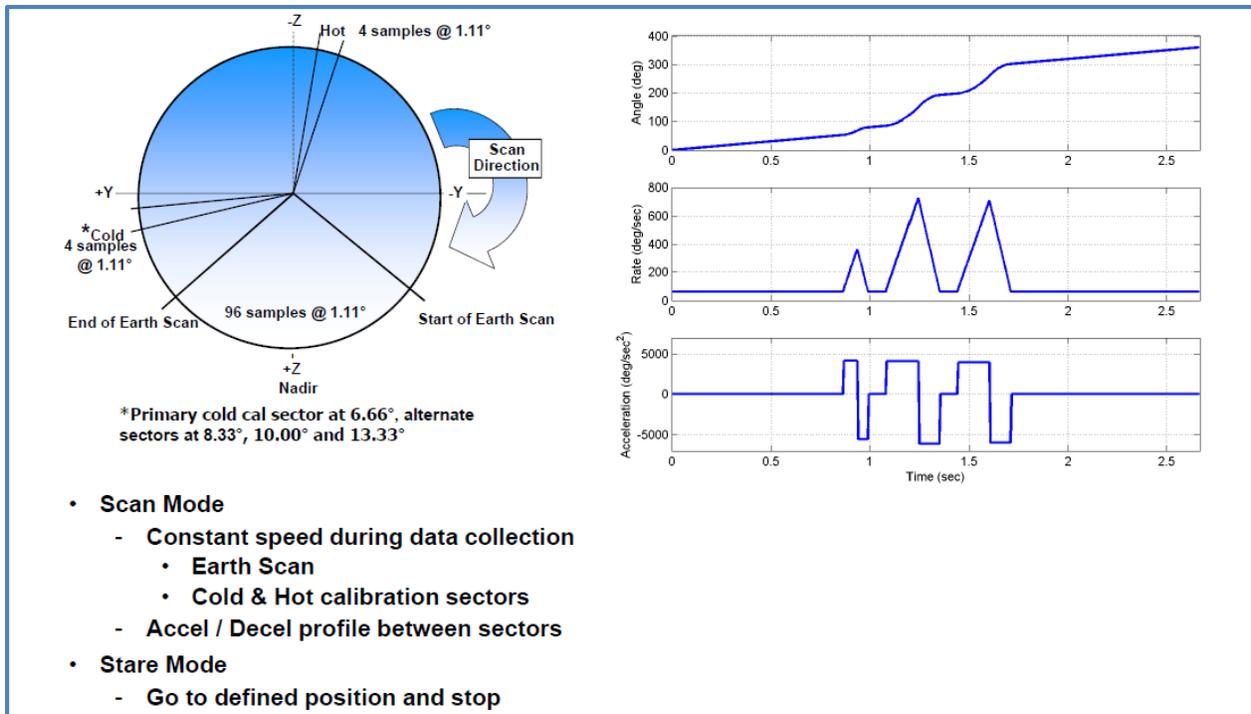
**Figure 6. ATMS Scan Profile Description**

The ATMS bearing application, by comparison, did not involve any reversals in its operation. The ATMS motion profile is uni-directional for the entire life of the instrument. There are accelerations and decelerations in the ATMS profile, but no opportunities for reversal of motion. A description of the ATMS profile is provided in Figure 6. Note that the primary data collect occurs during the Earth scan at constant speed as does the cold and hot calibrations. In order to minimize revisit time to the required 8/3 of a second per revolution, the scanner must accelerate and brake at extremely high levels (4500 to 5000 deg/s<sup>2</sup>) three times each revolution. At first it was thought that these high acceleration levels were responsible for ball skidding leading to premature life. However subsequent analysis showed that the dynamic loads were very small compared to the bearing preload making skidding unlikely.

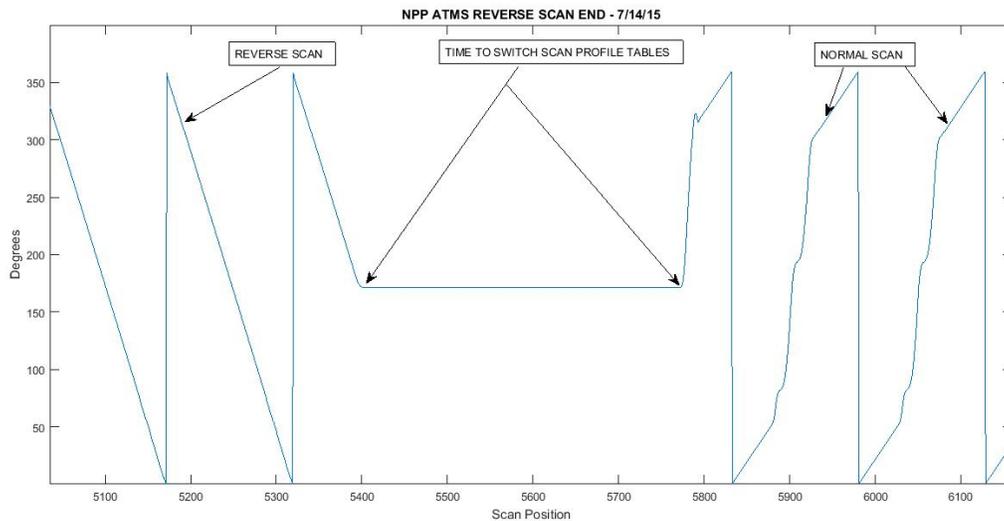
**Figure 13. Scanner Recovery from Reverse to Normal Scan**

Figure 13 shows the transition from reverse and then back to normal. The figure shows the scan angle vs scan telemetry sample number of the dataset. There are 148 data samples per complete scan rotation.

The daily reversals have been performed without interruption since August 24, 2015. Only one noticeable motor current ‘event’ has occurred since then and that happened early in the process on August 26, 2015. Since then the motor current has been rather stable with only small perturbations.
