PROBLEMS ENCOUNTERED DURING THE RECERTIFICATION OF THE GLORY SOLAR ARRAY DUAL AXIS GIMBAL DRIVE ACTUATORS

Marc Saltzman⁽¹⁾, Joseph P. Schepis⁽²⁾, Michael J. Bruckner⁽³⁾

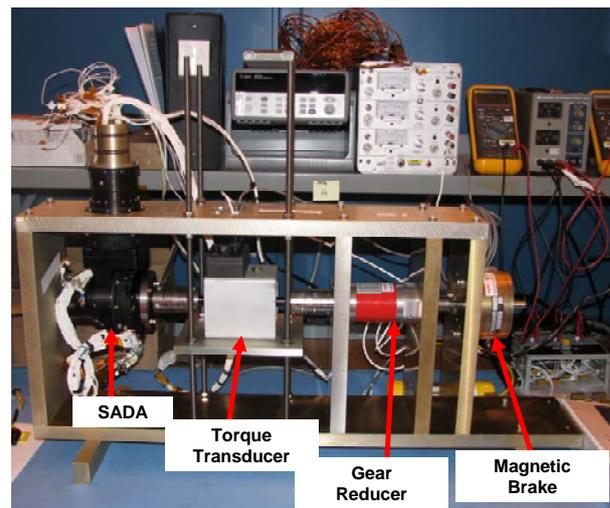
Figure 3 Torque Test Setup

Torque capability in the 150 in-lb to 190 in-lb (16.9 N-m to 21.5 N-m) range was produced prior to shipment but, as demonstrated by the plots in Fig. 4, there was either 30% degradation in torque or a serious flaw existed in the test apparatus. At least two days were spent checking the calibration of the torque test setup. The final test results for both SADAs are shown in Tab. 2. In this table, “N/A” indicates the configuration could not be tested without disassembly.

loss changes on the order of 30%. This mysterious torque loss was very perplexing. Moog was contacted to validate our torque testing approach, and they did validate it. Despite test setup confirmation indicating our torque measurement approach was not flawed, the sentiment at the time was that something was amiss with the setup and that the SADAs were, most likely, acceptable. A large contributor to this sentiment was the fact that the threshold voltage measurements were very reassuring. Nevertheless, NASA and Orbital agreed to follow the logic flow of our recertification decision tree and send the units back to Moog for a set of confirmation tests. At the time, it was assumed that some detail of the test setup or apparatus was flawed and that the inconsistency between the threshold test data and the torque test data would be resolved when Moog retested the actuators using the original test equipment.

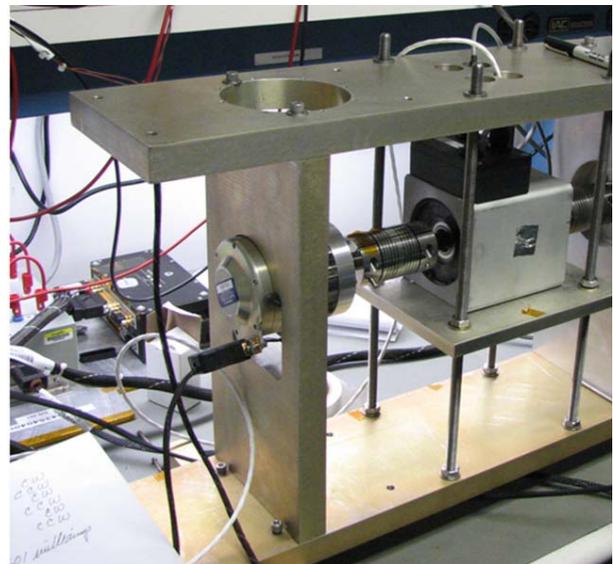
Figure 5 Moog Test Actuator Mounted in Altered Glory SADA Test Apparatus

using their test equipment but testing across the entire range of operation in the way Orbital had tested the SADAs. While this was accomplished at Moog, Orbital adapted their torque test setup to accept the Moog test actuator shown in Fig. 5. The Orbital torque results for the test actuator were in close agreement with those from Moog indicating approximately 30% torque loss and thus adding even more concern that the SADAs had, in fact, degraded over the past several years of storage and occasional use with Glory integration and test activities. The original test program was completed and an executive test summary written to document the results.

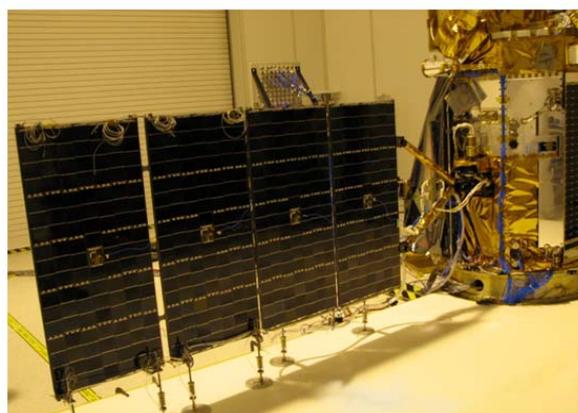
Figure 11 SADA Integrated onto Glory during Solar Array Deployment Testing

engineering team. The individual actuators were reassembled and subjected to a complete series of acceptance tests including two axes of vibration and two thermal vacuum cycles. The actuators were received at Orbital in early June 2008 and integrated onto the Glory observatory in early July. Fig. 11 shows the SADAs successfully integrated onto the Glory observatory during solar array deployment testing.

Based on the aforementioned findings, Orbital revised the Moog service agreement to include complete replacement of all harmonic drive bearings in both SADAs 1 & 2. While not contributing to the degradation the cotton phenolic wave generator bearing retainers were vacuum impregnated using an extended time of 3 days as recommended by the NASA
